Wychwood Wild Garden: Report on the Restoration of the Canals

September 2014

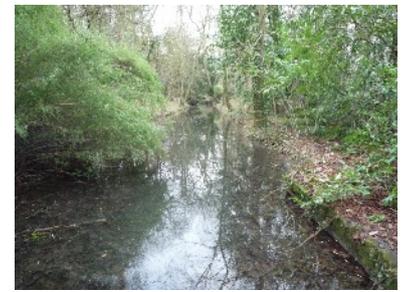
The canal was in poor condition with heavy silt build up and with trees growing in the banks. There were also major leaks on the west side. The approach to the restoration was to realign the banks as close to their original as possible with Nicospan and to use the dredged silt to fill the space created behind the Nicospan barrier. This would avoid the problems of removing significant quantities of silt from the site.

The lower canal before restoration

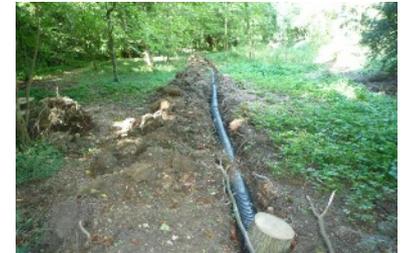
The overland bypass pipe

The next phase was to divert the stream with a pipe from the middle canal, using a temporary overland pipe that would remain in position while the restoration work was carried out. This work was carried out in conjunction with the Cotswold Volunteers.

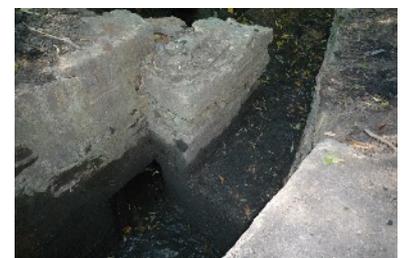
The excavated sluice culverts

At the same time the run-off culverts were excavated and new pipes installed. The area below the dam has now been filled in and a new path and bridge constructed around the bottom of the dam.

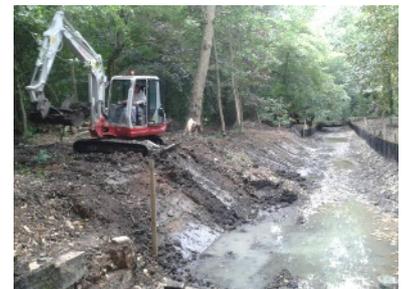
Dredging the lower canal

The main work of dredging the silt and reserving this to build the new banks was contracted out. The digger also removed the tree stumps growing in the banks.

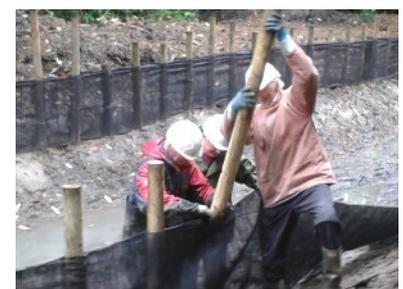
Installing the Nicospan

The new banks are formed using a geotextile membrane called Nicospan, fixed with posts every half metre and tied back by wire to stress posts to take the weight of the silt in-fill. The silt took a few months to dry out but now allows a new and stable bank to develop.

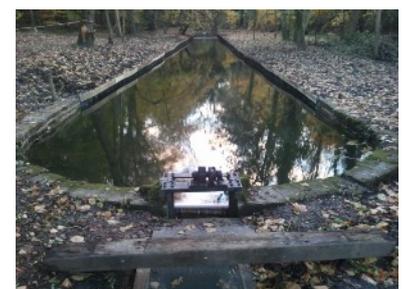
The lower canal after restoration

The completed canal edges have been faced with whaling boards to add strength but which still allows vegetation to grow over the top of the boards and through the membrane to form a new natural bank.

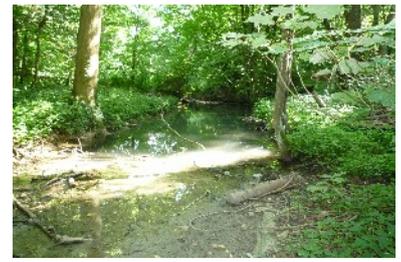
This canal was in very poor condition, with major leaks around the dam, considerable silting and debris, and both the retaining stone walls were deteriorating. A substantial amount of clay had previously been dumped around the dam which made investigations more difficult - all this clay needed to be excavated.

The upper canal before restoration

The canal was dredged back to the clay lining which was repuddled where necessary. A limited length of Nicospan was installed on the curves of the canal to minimise erosion. The flow over the waterfall from the Round Pond was diverted through pipes while work was undertaken. Both the retaining stone walls were taken down and rebuilt using new walling stone. The outflow from the Round Pond was repaired and a new waterfall lip cast in position.

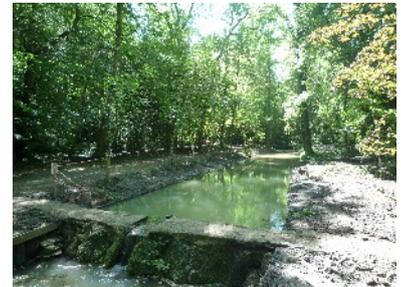
This canal was very shallow as a result of accumulated silted and seriously eroded around its dam, but otherwise there were no serious issues identified. The decision was therefore taken to only partially reline the banks with Nicospan, leaving the rest dredged down to the original clay bottom. The result is a natural bank edge along the whole length of the canal, which when fully dried out will allow for vegetative growth. The existing sluice was replaced to ensure a watertight seal and the canal reflooded.

The middle canal after restoration

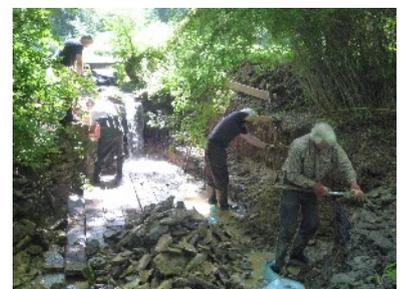
The reclaimed stone from the two retaining walls in the upper canal was of very poor quality and an additional 5 tons of walling stone was required.

New stone retaining walls

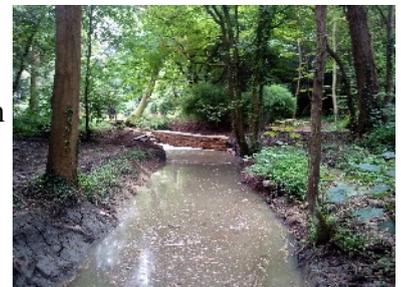
The upper canal after restoration

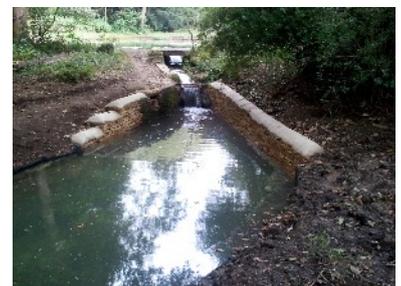
The upper canal after restoration
